City of Moose Jaw - Engineering Department
Executive Committee Report: Sunningdale Sewer System
April 11, 2016

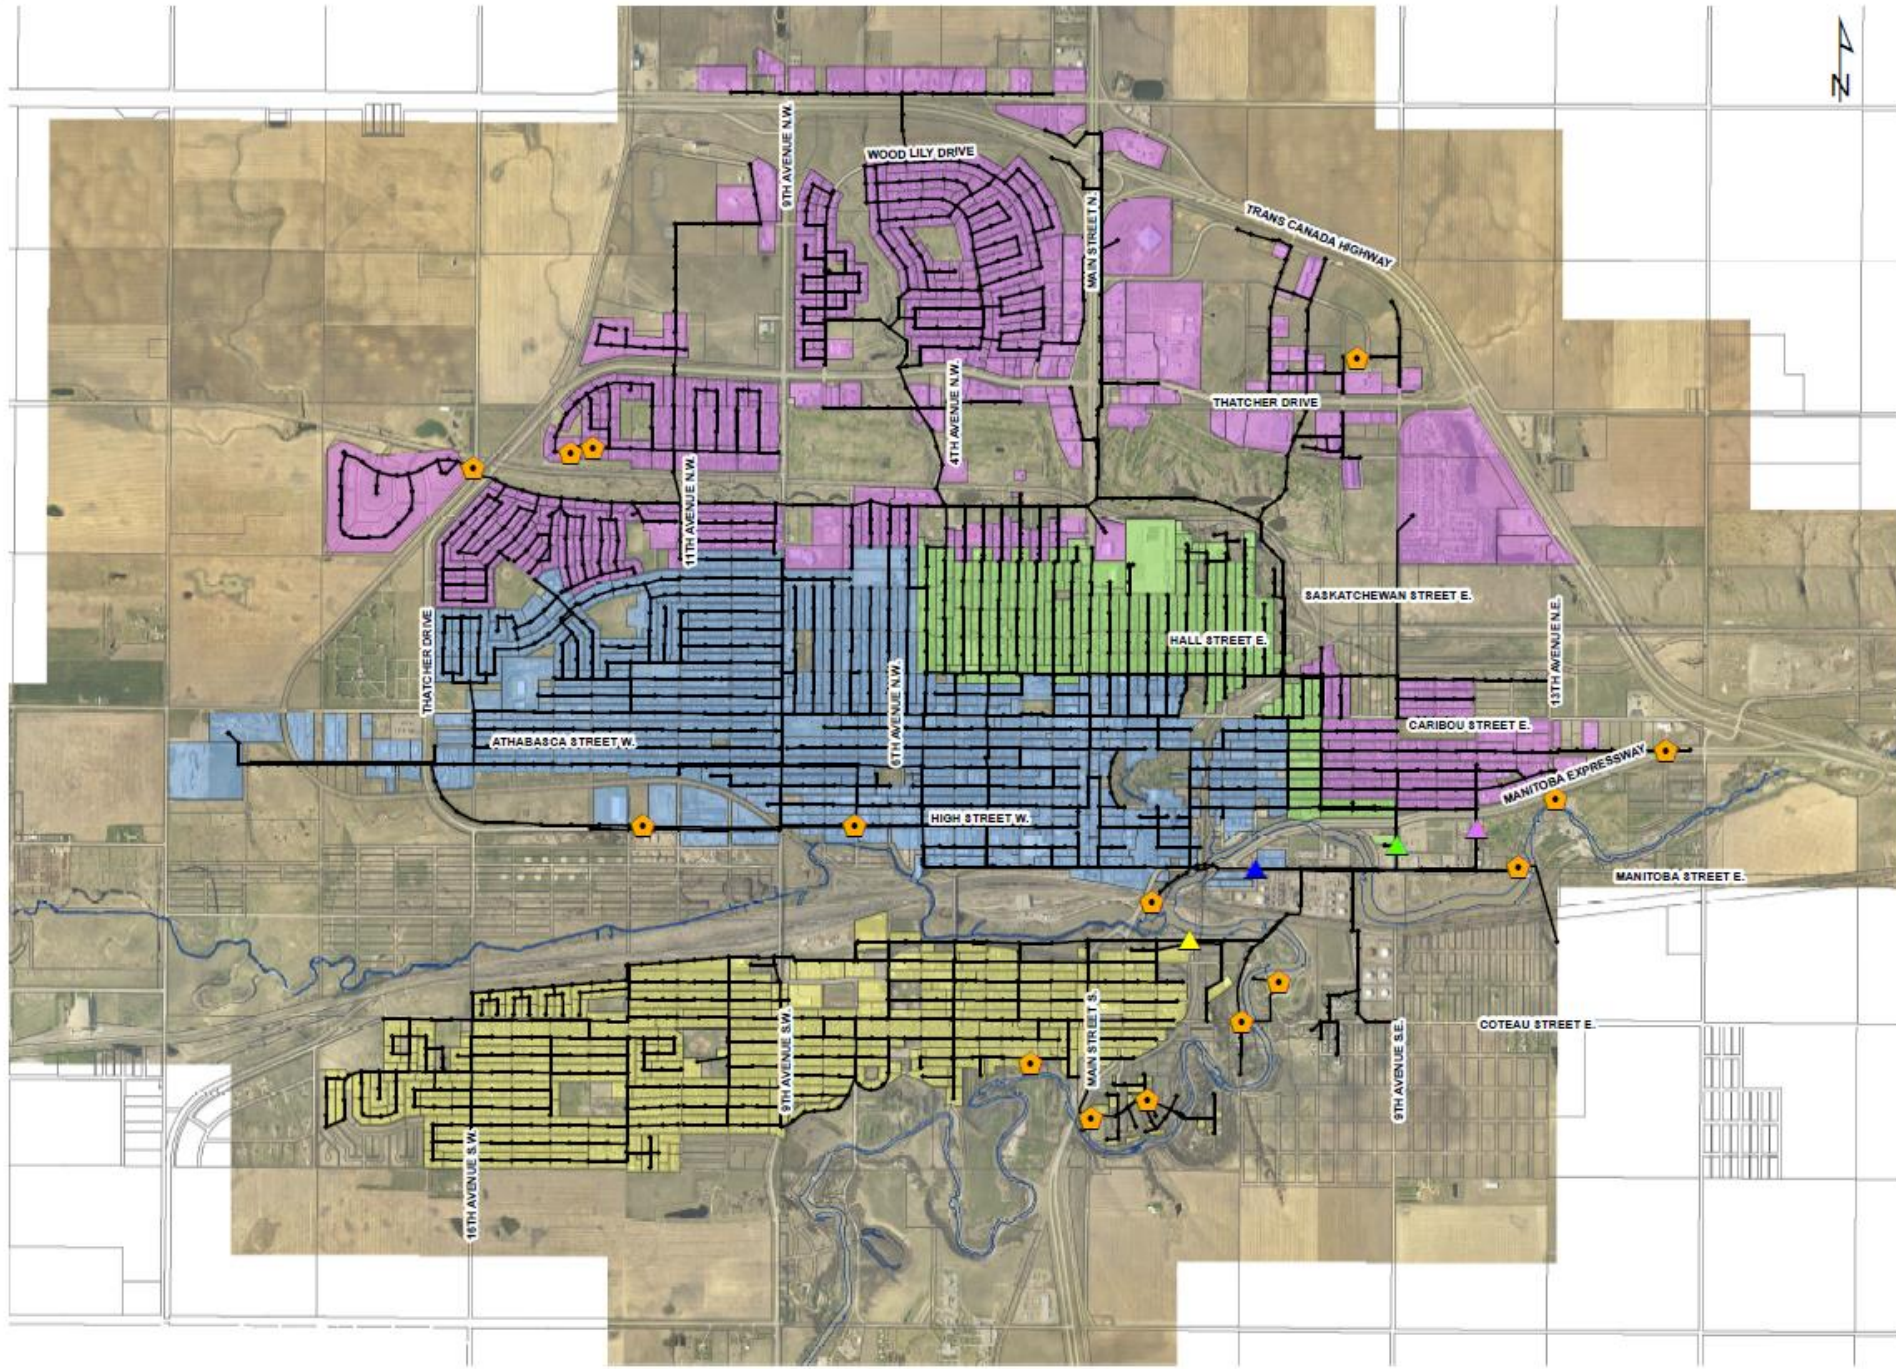
FIGURE 4.4

WASTEWATER SYSTEM
EXISTING SANITARY NETWORK
FLOW MONITORING LOCATIONS
